**Storm Water Quality Management Plan
Part B
Baseline Characterization Report
327 IAC 15-13-7**

Prepared For:
City of Franklin, IN

Prepared By:
COMMONWEALTH[™]
ENGINEERS, INC.
7256 Company Drive
Indianapolis, IN 46237

Part B Baseline Characterization Report

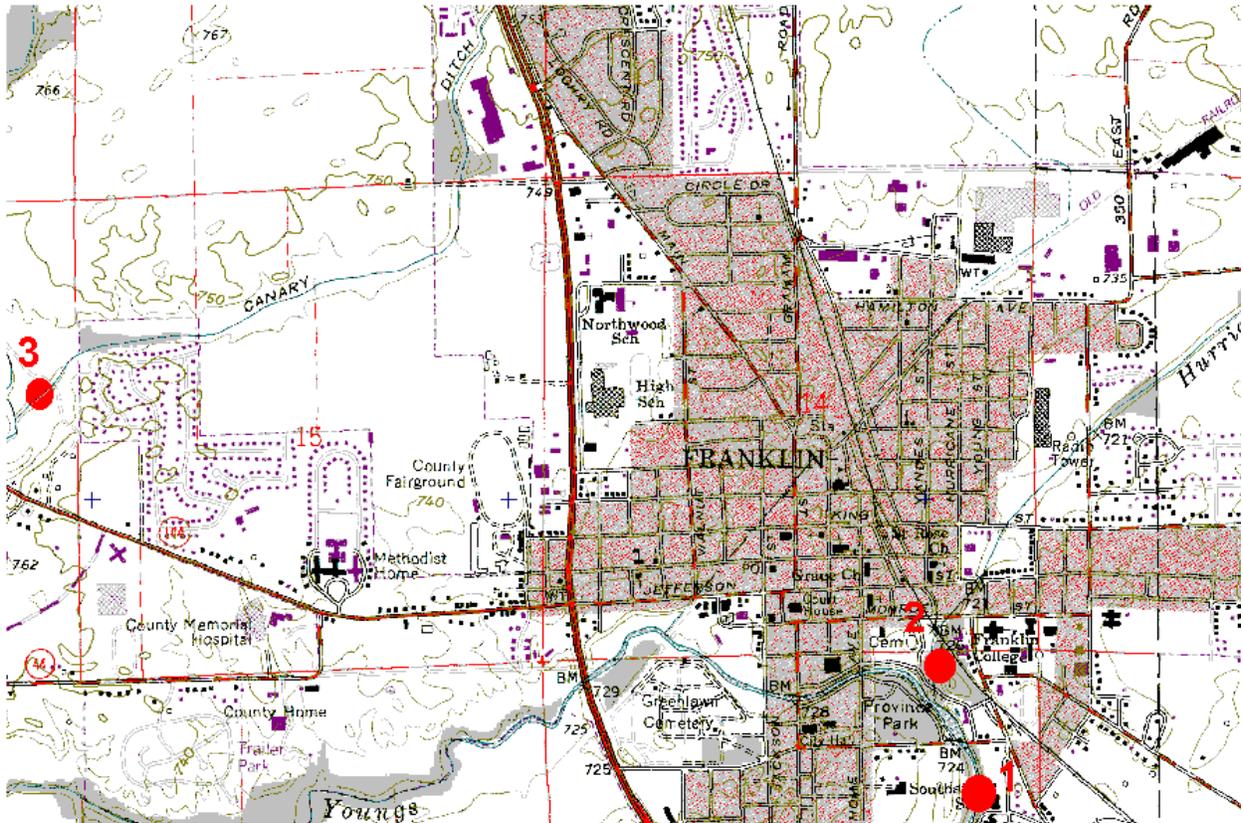
Figure 2: New Data Sites

To update information on the biological integrity of streams in the Franklin area, 3 sites were chosen for study:

- Site 1: Young's Creek
- Site 2: Hurricane Creek
- Site 3: Canary Ditch

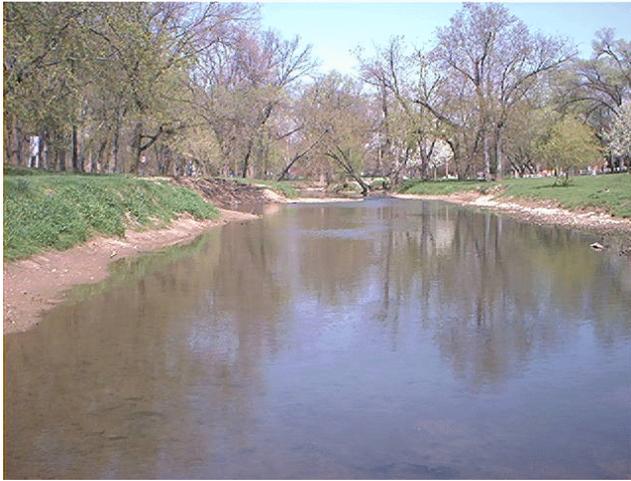
Site 1 – Young's Creek

Franklin Sampling Sites 1 - 3: Figures 3-5

In contrast, Young’s Creek had a biotic index score 35 points lower than its habitat score. This site had seriously degraded water quality. Excessive sediment inputs was probably the major problem, since the sediment-tolerant midge species *Orthocladius obumbratus* was by far the most common animal present.

Stream bank erosion was severe on both Hurricane Creek and Young's Creek. Much of the excessive sediment inputs could be corrected by stabilizing the stream banks. A bioengineering technique involving establishment of a healthy stream bank plant community is recommended.
